NATIONAL ADVISORY COMMITTEE FOR AERONAUTICS

TECHNICAL NOTE

No. 1203

A FLIGHT INVESTIGATION TO INCREASE
THE SAFETY OF A LIGHT AIRPLANE

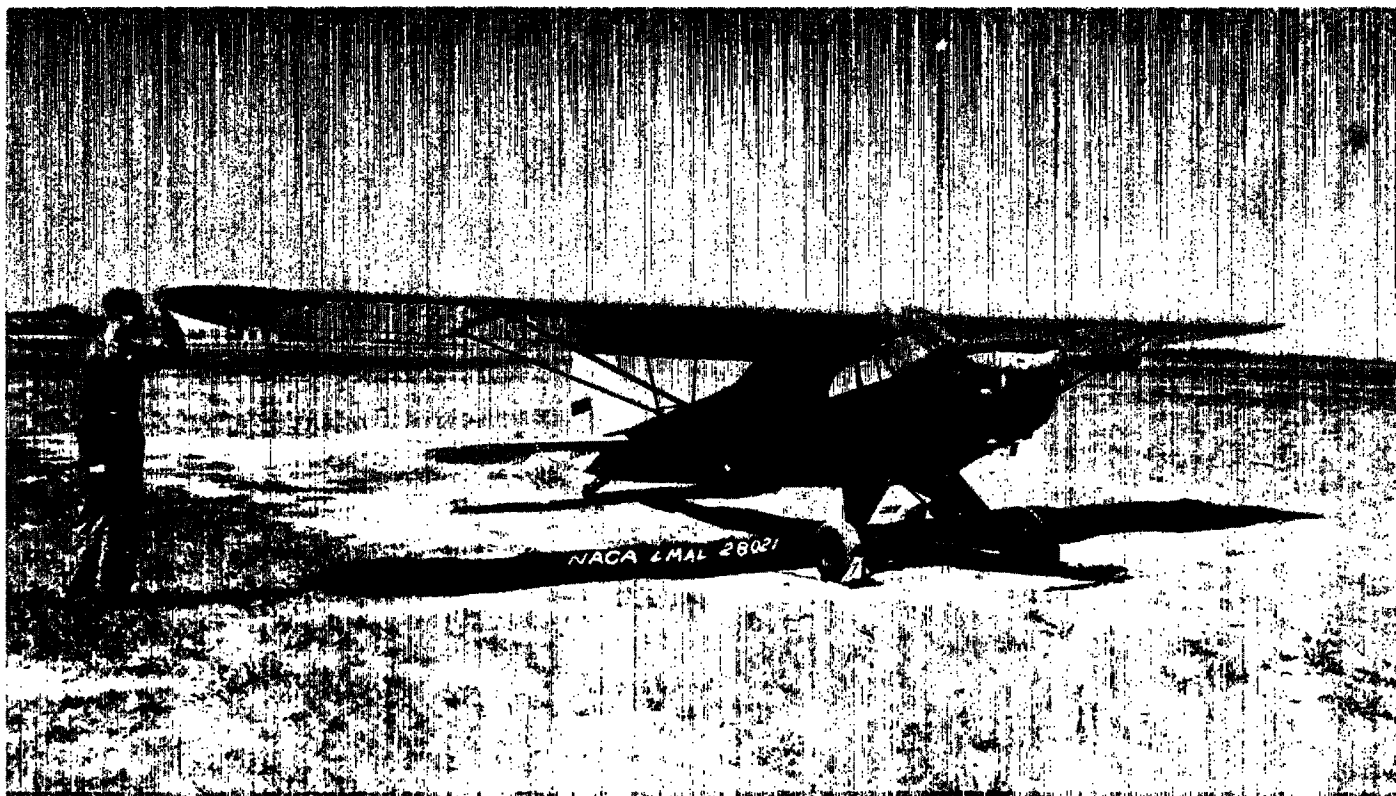
Figure 1.- Airplane used in tests.

(a) Three-quarter front view.

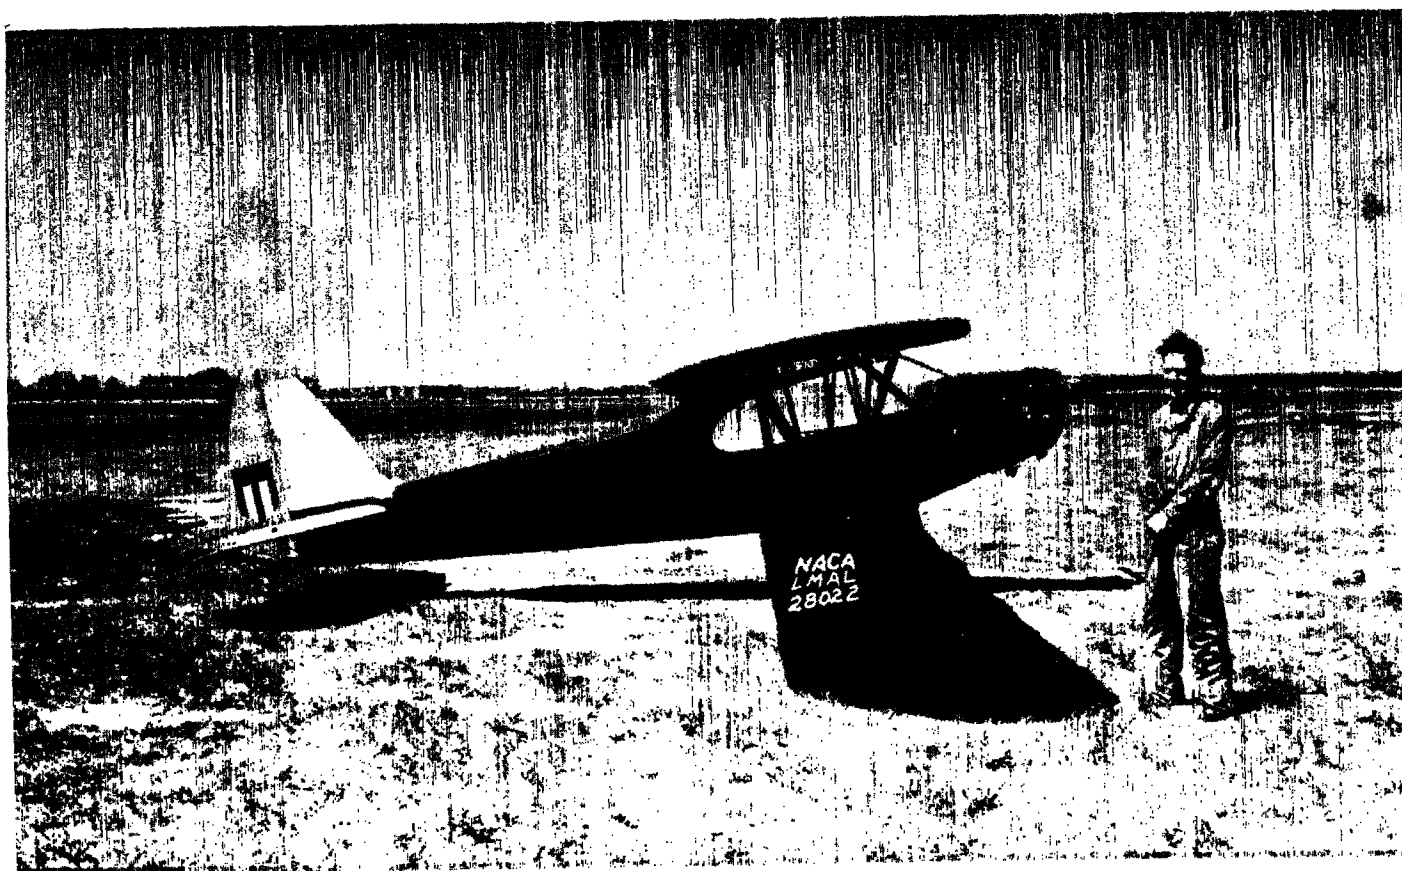
Figure 1.- Continued.

(b) Side view.

Original	Modified (dashed line indicates no change)
Vertical tail (see figs. 1(b) and 4):		
Fin:		
Area, sq ft	4.02	7.6
Rudder:		
Area, sq ft	6.55 (including horn balance)	5.9 (no horn balance)
Travel, deg	± 33	± 15
Center of gravity:		
Forward position		
(12 gal gas 190 lb passenger and 20 lb parachute, 110 lb pilot and 20 lb para- chute), percent M.A.C.	24.0	30.0
Rear position		
(2 gal gas, no passenger, 190 lb pilot and 20 lb para- chute), percent M.A.C.	30.0	37.0

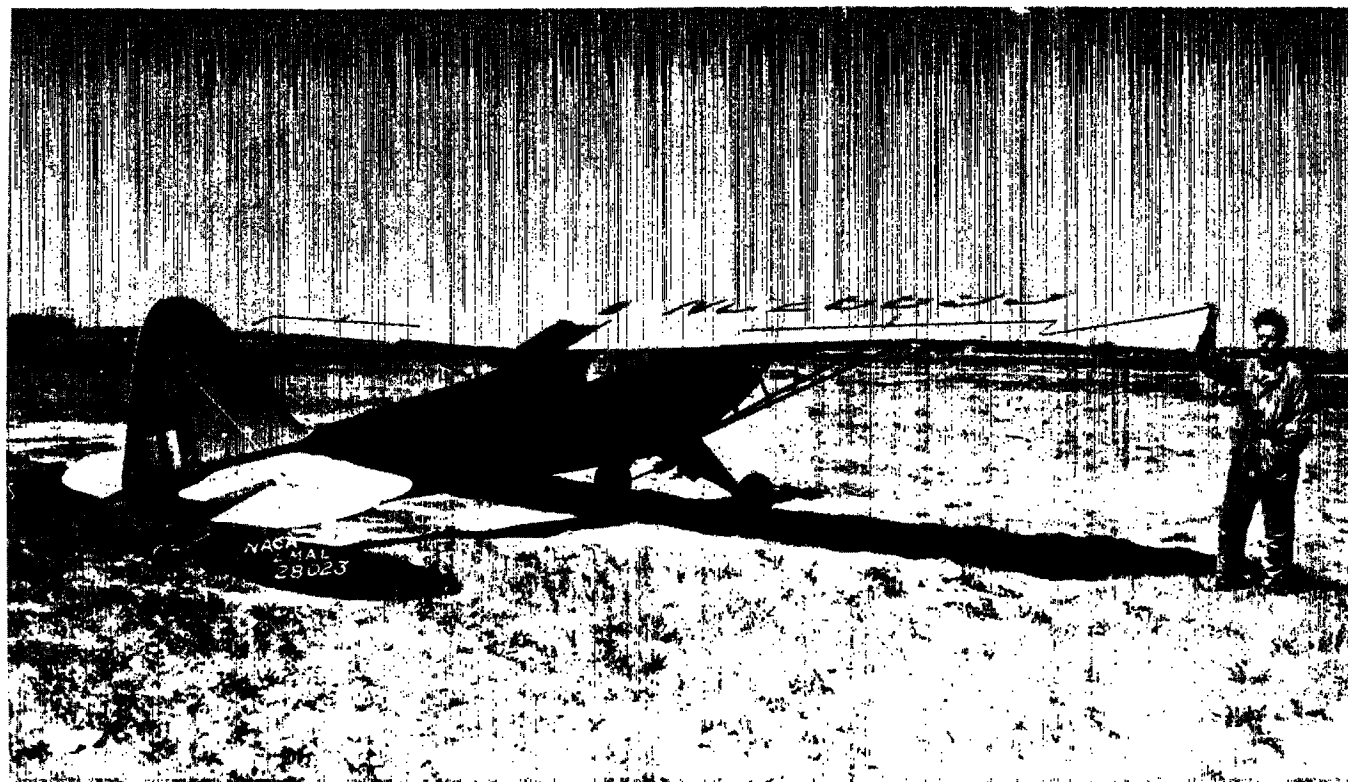
Figure 1.- Concluded.

(c) Three-quarter rear view.

this pitching oscillation, the break at the center section caused by changing the wing incidence was faired alternately by fabric fillets, balsa fillets, and sheet-metal fairing over the entire center section. The center-section stall could not be eliminated, but the balsa fillets produced the best results and were used in the final configuration. These fillets may be seen in figure 1(c).
